Failure Processes in Penetrators With Shear-Control Grooves

by
Stephen A. Finnegan
and
John Pearson
Research Department

NOVEMBER 1984

NWC Technical Publication 6542

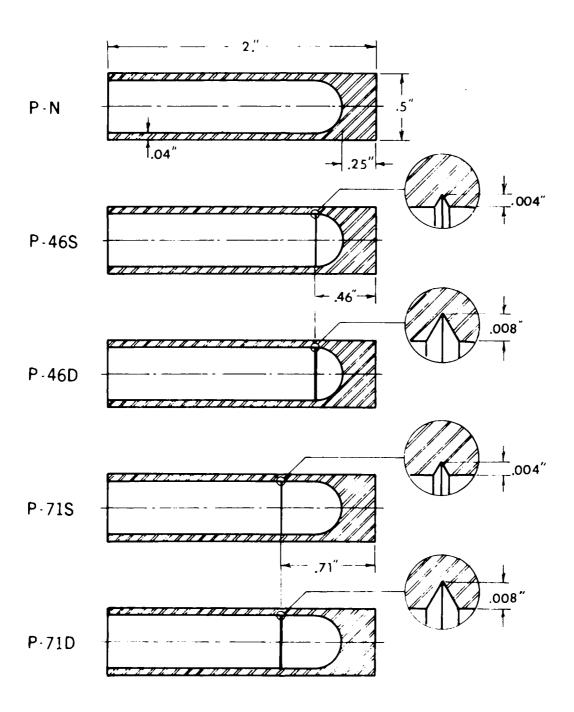
FIGURE 1. Cross-Sectional Views of Test Projectiles with Details of Grooves.

Penetrators consisted of 2-inch-long, 0.5-inch-diameter, flat-fronted, hollow steel eylinders machined from SAF 4340 steel bar stock. The nose of the penetrator was 0.25 inch thick in the center, and the cavity wall was 0.04 inch thick. The inside surface of the impact end was machined to a hemispherical shape in order to minimize stress concentrations that would ordinarily occur at the transition between nose and cavity wall during impact. Penetrators requiring a shear control groove contained a single circumferential "vee" groove with a 60-degree included angle and a depth of either 0.004 or 0.008 inch machined into the inside surface of the cavity wall. The circumferential groove was positioned either 0.46 or 0.71 inch from the front of the penetrator, A 0.46-inch distance placed the groove exactly at the junction between the nose and wall and in the primary zone of failure, while a 0.71-inch distance located the groove behind the expected zone of failure. After being machined, penetrators were heat-treated to a hardness of 38 40 R_C, after which the outside surface was plated with a thin (about 0.001-inch) coating of copper in order to minimize damage to the gun barrel during launching. The different penetrator designs used in these studies are shown in Figure 1. The relative overall behavior of the different designs has been described previously (Reference 4).

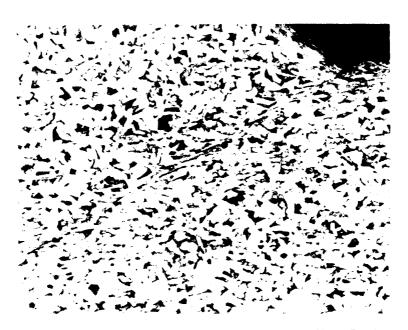
FIGURE 3. Photomicrograph of a Concentrated Shear Band in a Fragment from an Explosively Loaded SAE 1015 Steel Cylinder with a Shear Control Grid (100X Magnification).

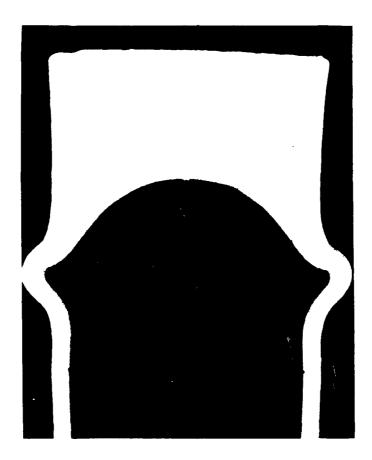
FIGURE 16. Section-View of Penetrator With Shallow Control Groove Behind Primary Failure Zone (P-71S) After Impact on Concrete Target at 2460 ft/s.

Figures 16 and 17 to the street of observe the control groove at a distance of 0.71 inchestion, a control of the first the penetrator shown in Figure 16 had a shallow groove, it imports to the first Control grooves placed at this location had little effect on sidew 40 of the street of incompact velocities, complete the street of stall occurred in the primary zone of tailure.

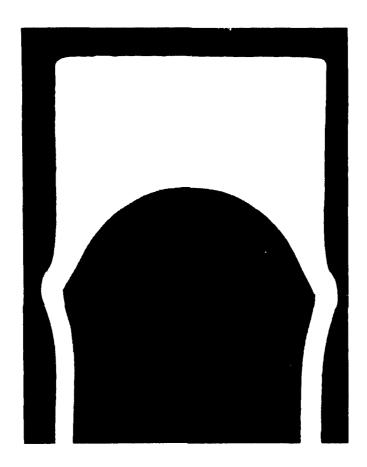
FIGURE 15 Section View of Penetrator With Deep Control Groove in Primary Failure Zone (P 46D) After Impact on Concrete Target at 2130 ft/s.

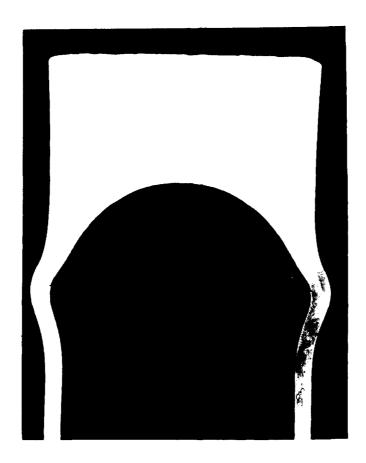
FIGURE 14. Section-View of Penetrator With Shallow Control Groove in Primary Failure Zone (P-46S) After Impact on Concrete Target at 2320 ft/s.

The effect of introduction of the constraint of the primary zone of failure can be seen in Figures 14 and the windle down the forward ends of penetrators that impacted at 2320 and 2450 of the postatively. Both penetrators had grooves located 0.46 inch from the treatment of Figure 14 had a shallow groove, while the postation of Ligure 14 had a

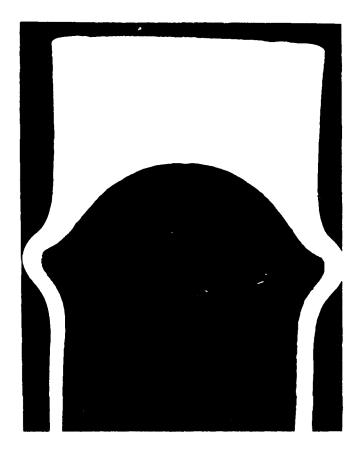
FIGURE 13. Section View of Smooth Wall Penetrator (F.N.) After Impact on Concrete Target at 2490 fts.

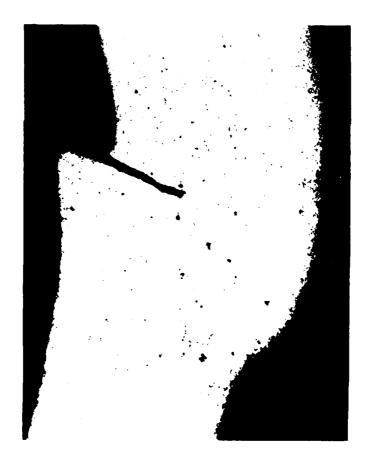
Figure 11 shows a control groove as it appears in the bulged region of a penetrator which impacted at 2830 ft/s. This projectile had a deep control groove located 0.46 inch from the front surface. The groove was almost closed during the deformation of the sidewall. A white shear band can be seen extending from the region of the groove to the outside surface of the sidewall. Figure 12 shows an enlarged view of the shear band. It appears that several zones of incipient shear fracture have formed within the band. The propagation and linking together of such fractures along the entire length of the shear band would ultimately produce catastrophic failure and separation by complete shear fracture through the wall of the penetrator. This type of shear-band associated failure in the sidewall of a projectile can be seen in Figure 6. This projectile, which had a deep control groove located 0.46 inch from the front surface, failed in the sidewall at an impact velocity of 2950 ft/s. Microstructural examination showed that the shear fracture in the sidewall had propagated through a precursor band of concentrated shear in the microstructure of the steel.

FIGURE 11. Photomicrograph of Incipient Shear Failure in a Primary Failure Zone Containing a Deep Control Groove (P-46D) After Impact on a Steel Target at 2830 ft/s (50X magnification)

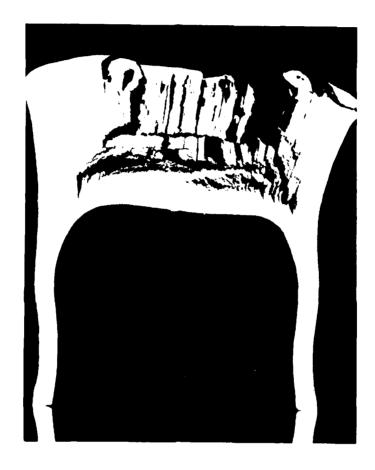
FIGURE 8. Section-View of Penetrator With Deep Control Groove Behind Primary Failure Zone (P-71D) After Impact on Steel Target at 2970 ft/s.

Figures 7 and 8 show penetrators which impacted at similar velocities of 2980 and 2970 ft/s, respectively. Both penetrators had grooves located 0.71 inch from the front end of the projectile and outside of the primary zone of failure. The penetrator of Figure 7 had a shallow groove, while the penetrator of Figure 8 had a deep groove. Although the buckling was somewhat greater for the deep groove, neither of these penetrators sustained shear fractures in the sidewall. As all of these figures show, the primary mode of failure for the penetrators which impacted thin steel targets was disintegration of the nose and not failure of the sidewall.

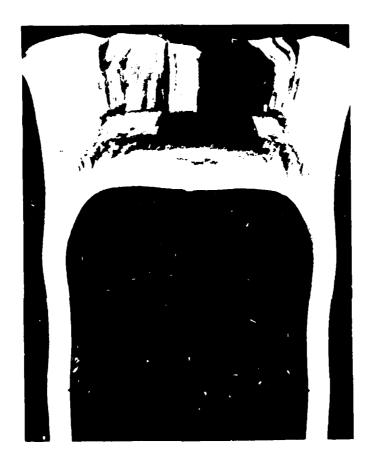
FIGURE 7. Section View of Penetrator With Shallow Control Groove Behind Primary Failure Zone (P-71S) After Impact on Steel Target at 2980 ft/s.

White-etching shear bands were identified both in the surface areas of the nose and in the bulged areas of the sidewalls. In both locations the shear bands were associated with the formation of shear fractures. Figures 9 and 10 are representative of the concentrated shear bands which formed along the outer edge of the projectile face. Figure 9 shows multiple bands as they appeared in a projectile which impacted at 2980 ft s, while Figure 10 shows a single band formed on the opposite side of the same projectile (see Figure 7).

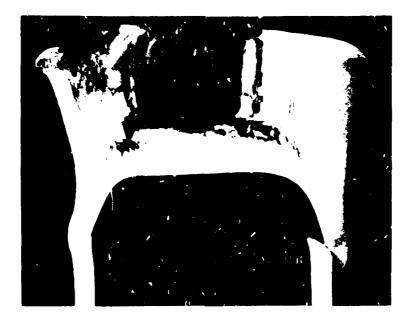
FIGURE 6. Section-View of Penetrator With Deep Control Groove in Primary Failure Zone (P-46D) After Impact on Steel Target at 2950 ft/s.

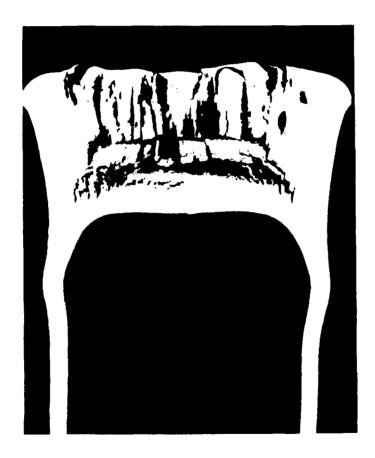
In addition to the damage sustained by the nose section, buckling occurred in the sidewall, mainly in the region just behind the nose section. The degree of buckling produced depended on the impact velocity and on the depth and location of the circular groove, if one were present. Figures 5 and 6 show this sidewall effect for penetrators which impacted at similar velocities of 2985 and 2950 ft/s, respectively. Both penetrators had grooves located 0.46 inch from the front end of the projectile so that the grooves were located in the primary zone of failure. The penetrator of Figure 5 had a shallow groove which resulted in minor buckling not much different from that sustained by the plain wall penetrator of Figure 4 at about the same impact velocity. The penetrator shown in Figure 6 had a deep groove which resulted in complete failure of the sidewall due to shear fracture emanating from the groove.

FIGURE 5. Section-View of Penetrator With Shallow Control Groove in Primary Failure Zone (P-46S) After Impact on Steel Target at 2985 ft/s.

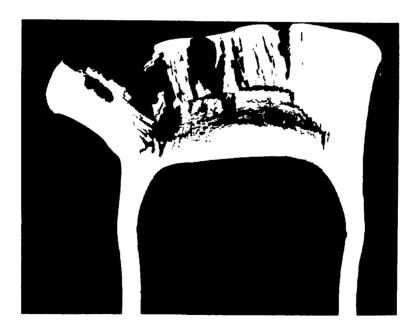
Figure 4, which is an axial cross section of the forward portion of a plain-wall penetrator (no grooves) which impacted at 2995 ft s, shows the various failure patterns encountered. Nose damage includes (1) lateral bulging of the frontal portion accompanied by axially oriented tensile fractures, some of which radiate outward from the center of the nose and others of which appear as circular ring fractures, with both geometries occasionally terminating with a shear lip at the frontal surface; (2) shear bands along the outside edge of the frontal surface; and (3) a family of parallel tensile fracture surfaces identified as spall fractures, which resulted from stress wave reflections off the back surface of the nose. As many as five spall surfaces were found at the higher impact speeds, a process requiring very high-amplitude, short-duration stress transients.

FIGURE 4. Section-View of Smooth-Wall (P-N) Penetrator After Impact on Steel Target at 2995 ft/s.

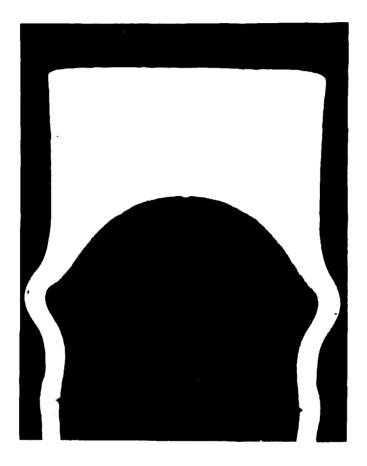
FIGURE 17. Section-View of Penetrator With Deep Control Groove Behind Primary Failure Zone (P-71D) After Impact on Concrete Target at 2448 ft/s.

These broad bands of deformation were first noticed when polished and etched half-sections were viewed under oblique lighting conditions. Under a highly directional fiber-optic light beam, they showed up as either light or dark regions depending on the orientation of the sample with respect to the beam. When viewed under normally incident lighting the bands were difficult to see although some alignment of the grains was observed. In specimens that impacted the simulated concrete targets, the deformation band directed toward the nose of the projectile was generally more distinct, as though it had undergone a greater degree of deformation. When wall failure by shear fracture occurred, the fracture normally propagated through the band with this particular orientation. Deformation bands of this type were also sometimes associated with the lesser bulging which occurred when the grooves were located outside the primary failure zone. In such a situation, both of the deformation bands appeared to be of similar intensity. Complete failure of the wall was not observed at this location, although some permanent bulging was observed at the higher impact velocities, as shown in Figure 17.
